Environmental/Natural Resource Inventory Update

**Englewood Environmental Commission
City of Englewood, Bergen County, New Jersey**

December 2010

Prepared by:
Dewberry-Goodkind, Inc.
600 Parsippany Rd
Ste 301
Parsippany, NJ 07054

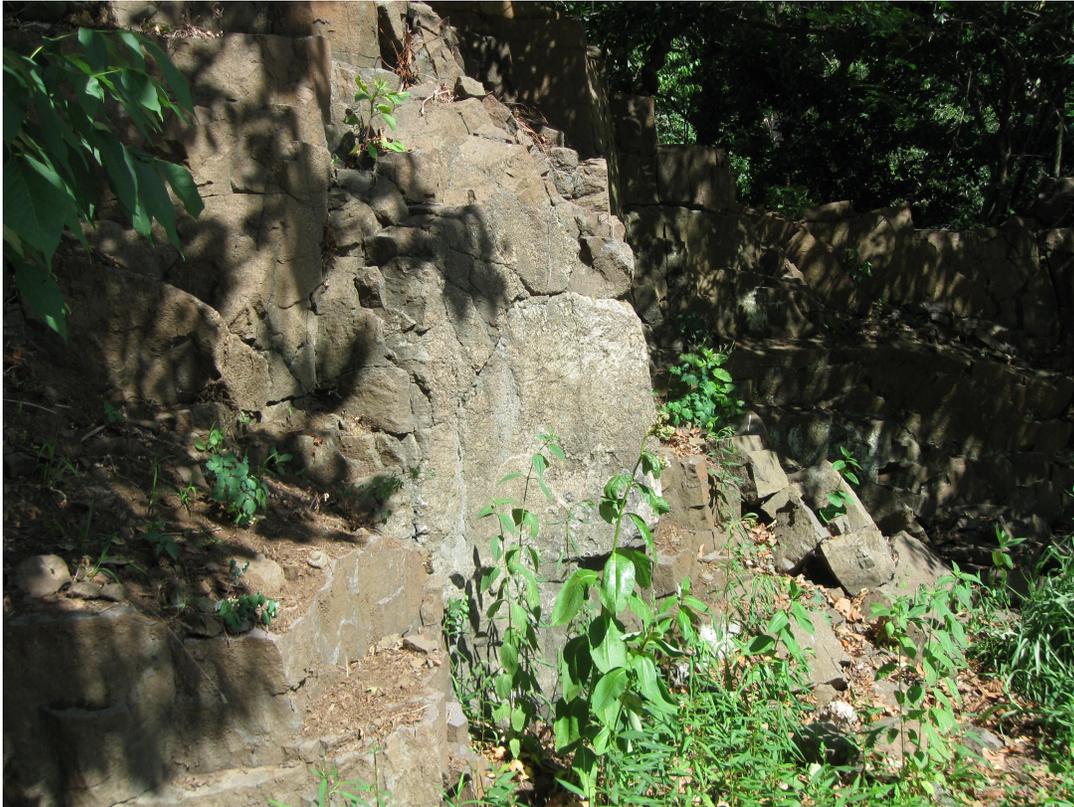
Photograph 3: Diabase outcrop in former quarry at Flat Rock Brook Nature Center

Jurassic Diabase (Jd). According to the United States Geologic Survey (USGS), Jurassic diabase is an igneous volcanic rock formed by intrusion of mafic (silica deficient) magma that originated from the Earth's mantle and was intruded into the sedimentary rocks of the Newark Group. The diabase in Englewood (also known as the Palisades Sill), is a crystalline medium- to coarse grained subophitic matrix and formed in discordant stock-like intrusions of dark-greenish-gray to black bedrock. The chilled, contact margins with the surrounding sedimentary rocks are aphanitic to very fine grained. Diabase is dense, hard, and sparsely fractured. It is composed mostly of iron-rich minerals including plagioclase, clinopyroxene (mostly augite) and magnetite with subordinate ilmenite. Accessory minerals include apatite, quartz, alkali feldspar, hornblende, titanite, and zircon. Olivine is rare. Within about 655 feet above and 490 feet below the large diabase sheets, red mudstones are typically metamorphosed into indurated, bluish-gray hornfels commonly with clots or crystals of tourmaline or cordierite, whereas argillitic siltstone is metamorphosed into brittle, black, very fine grained hornfels. The sheet-like intrusions are as much as 1,180 to 1,310 feet thick. Dikes range in thickness from 10 to 50 feet and several miles long. Thickness of the stock-like bodies is unknown⁴. The Palisades Sill forms a high ridge along the Hudson River for miles from Bergen Point, New Jersey, to Haverstraw, New York. A crushed stone quarry that operated between 1900 and 1925 mined the diabase (Photograph 3) off of Jones Road. The former quarry is now part of Flat Rock Brook Park.

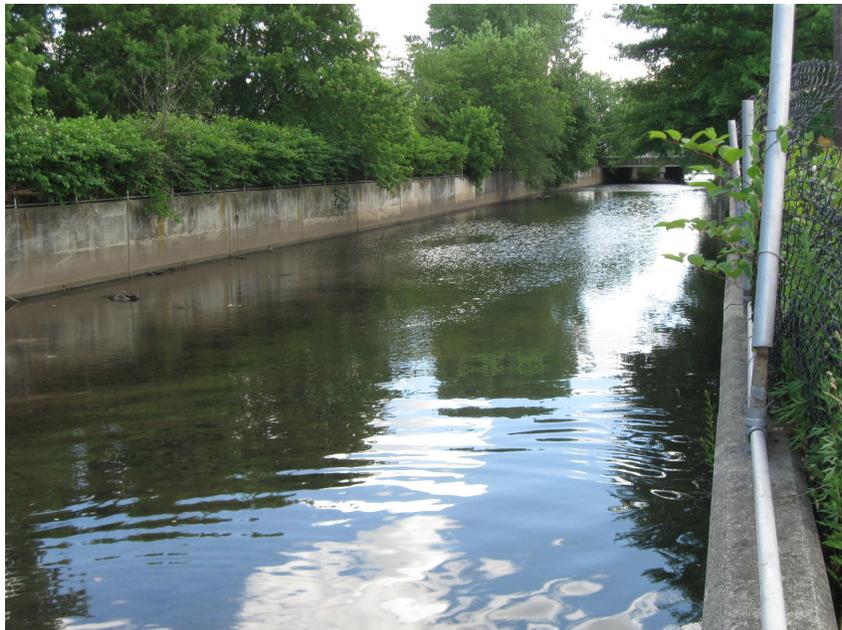
Photograph 6: Overpeck Creek Channel at Overpeck Road near Route 4.
